# Manhole Inspection Summary

Manhole # S21CC\_011MH

Insp Date: **10/24/07 1:02 PM**

**Location** Address: **1823 RIGGS-ALLEY-MOSHER** Cross Street: **MONROE-MCKEAN**

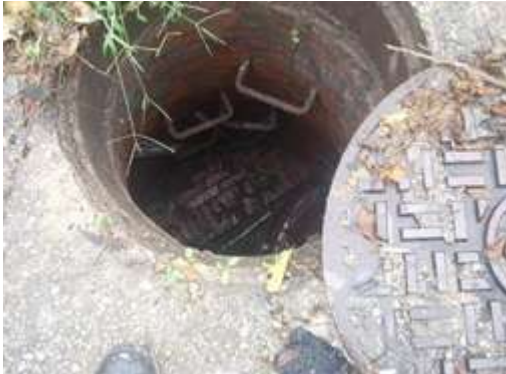
Defect 1

**Steps** Count: **5** Missing: **0** ☒ **Corroded**

CORRODED STEPS

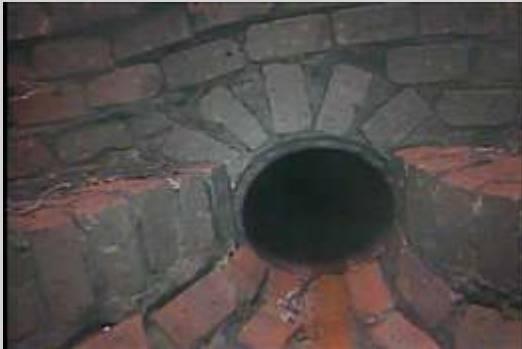
12 O'Clock Outflow

8 in. Circular Gravity Sewer  
Pipe Out @ 12 O'Clock

Pipe Height: **8.4** (in.) Rod and Bar (Angled)  
Pipe Material: **Clay** ☐ Pipe Lined  
Invert Depth: **9.36** (ft.) Flow Characteristics: **Slow**  
Deposits: ☒ None ☐ Mud ☐ Sludge ☐ Debris ☐ Grease  
Silt Depth: (in.) Deposits Extent:  
Infiltration: **None** Pipe Seal Cond: **Sound**

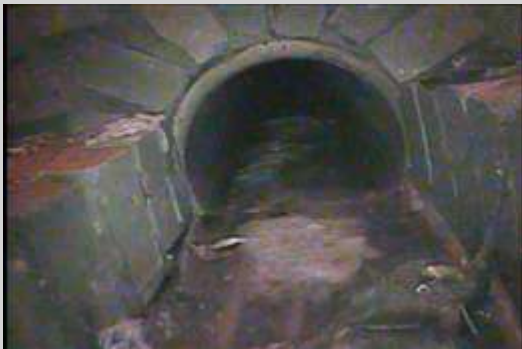
3 O'Clock Inflow

8 in. Circular Gravity Sewer  
Pipe In @ 3 O'Clock

Pipe Height: **8.4** (in.) Rod and Bar (Angled)  
Pipe Material: **Clay** ☐ Pipe Lined  
Invert Depth: **9.21** (ft.) Flow Characteristics: **Slow**  
Deposits: ☐ None ☐ Mud ☒ **Sludge** ☐ Debris ☐ Grease  
Silt Depth: **2** (in.) Deposits Extent: **Light**  
Infiltration: **None** Pipe Seal Cond: **Sound**
